OPERATING EXPERIENCE SUMMARY

Office of Nuclear and Facility Safety

November 4 – 17, 1999

Summary 99-46

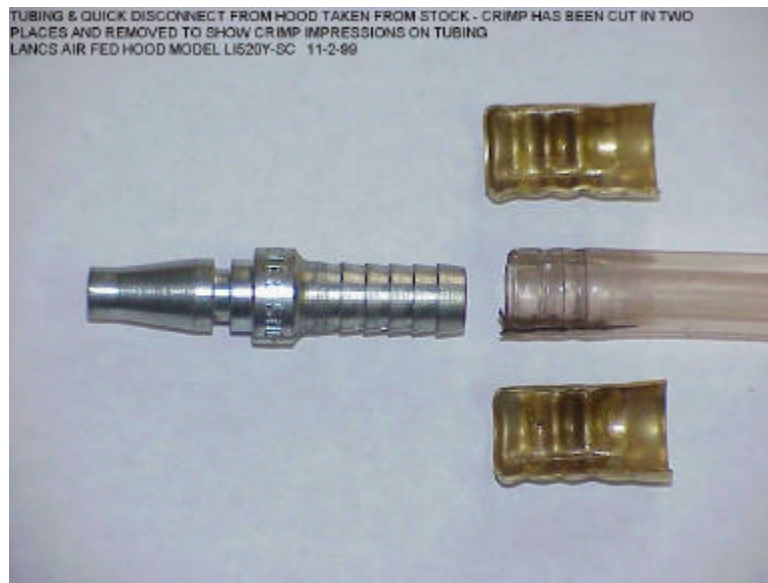
Figure 3- 1. LANCS Model L1520Y Assembly

On November 2, 1999, at the Hanford site, an electrician who was making repairs to an inert blower inside an airborne radiation area, lost his air supply when the tubing to his LANCS air-fed hood disconnected from the hood fitting. The electrician lifted the lower part of the hood to allow easier breathing and a radiological control technician escorted him out of the area. The radiological technician surveyed the electrician and found no evidence of contamination. Failure of an air supply can result in workers breathing contaminated air or losing consciousness. (ORPS Report RL--PHMC-FFTF-1999-0010)

The investigators determined that the electrical worker wore the air hood (LANCS model L1520Y) both for comfort and to prevent facial contamination while repairing an inert gas blower located in a contamination area. They also determined that the tube connection, at the hood, had no crimping collar to bind the tygon air supply tubing to the hood fitting. Safety personnel inspected similar hoods and found the supply tubing to be properly crimped. Investigators determined that the manufacturer performs the crimping before shipping the hoods. Site personnel contacted the manufacturer, LANCS, and reported the failure. Safety personnel checked similar hoods and found no additional problems with crimping. Figure 3-1 shows the type assembly used for the model L1520Y air hood.

Hanford training personnel revised respiratory use procedures to indicate that workers who wear respirators or air-supplied equipment should check their issued equipment for operability or defects before usage.

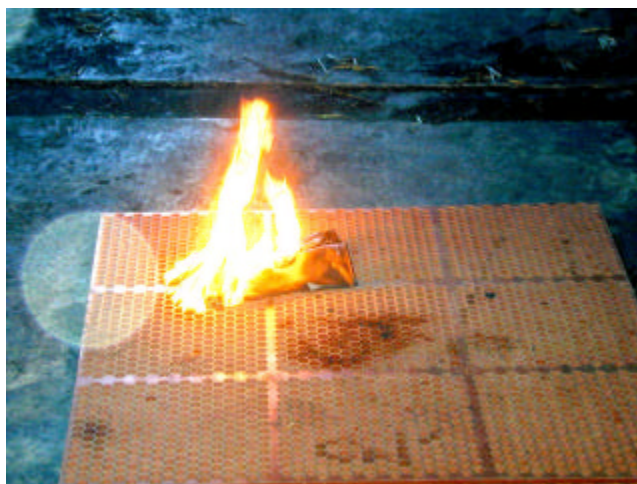
Figure 7-1. Burning Glove Igniting Rubber Floor Mat

On November 1, 1999, at the Pantex Plant, fire protection engineers identified safety concerns while testing rubber floor mats for ignition and combustibility. Pantex Weapons Program procedures require the combustible loading to be minimized, justified, and approved by fire protection engineers. Honeycomb rubber floor mats are used at the facility to reduce the risk of a high explosive drop in areas where high explosives safety is a factor. Various ignition tests demonstrated that the rubber mats ignited during credible fires making them a significant source of fuel. Fire protection engineers recommended removing the mats and replacing them with a noncombustible material or covering them with a noncombustible material. Materials used in high explosives areas can contribute to combustible loading, increasing the risk of loss from fire. (ORPS Report ALO-AO-MHSM-PANTEX-1999-0074)

Investigators determined that the honeycomb floor mats were excluded from the cell fire source term without adequate justification. Fire protection engineers performed a series of tests that demonstrated that the mats contributed to combustible loading. They used a 9-square-foot section of mat as a base on which to ignite paper wipes, isopropyl alcohol, butyl gloves, and nitrile TNT gloves. The mat ignited and continued to burn during the tests involving the alcohol and butyl gloves. Investigators determined that the airflow characteristics associated with the raised feet on the mats also contributed to flame propagation. Based on test results, fire protection engineers drafted an engineering evaluation identifying immediate compensatory measures that included prohibiting the storage of combustible materials on the mats and a process to heighten employee awareness about mat safety concerns.

Decisions to use rubber floor mats should be made with care because mats can contribute to a facility's combustible loading. As a minimum precaution, combustible materials should not be stored on or near rubber mats.
